ROOF ASSET MANAGEMENT

Commercial Warehouse Store

Work Order #	4999
Date	5/27/2023

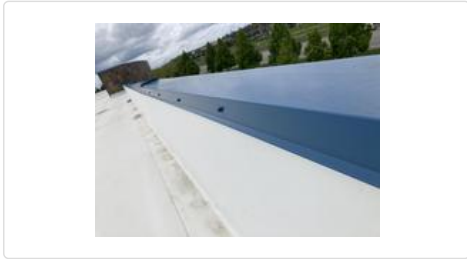
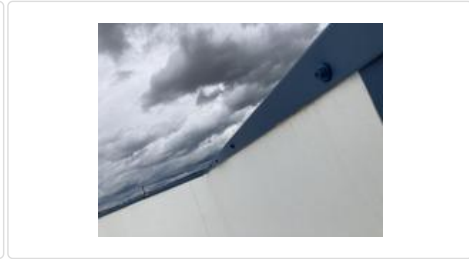
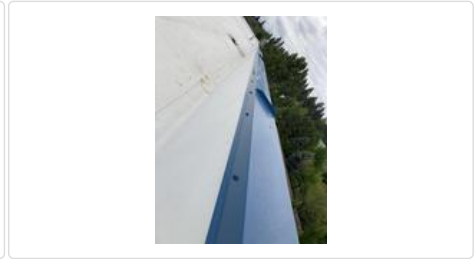
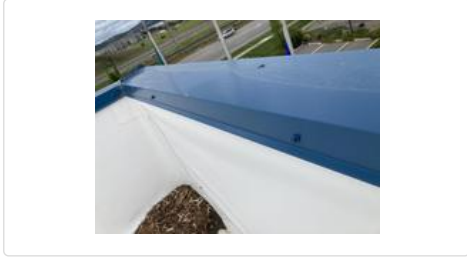
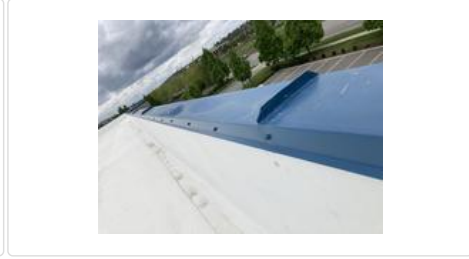
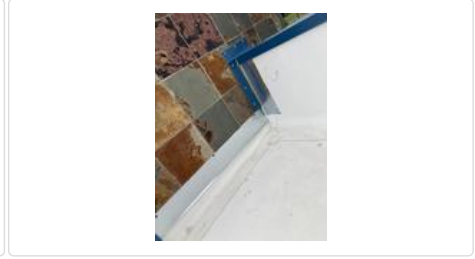
Item	Description
Before Photos of Entire Roof

Roof Condition	Roof membrane is in good condition. The roof has some standing water and some debris around drains. Other than that all is good.
Inspect - Traffic, Screws, Etc	Traffic areas on the roof were all good no issues. The screws on the coping metal are in good condition as well. Located a couple of voids on the counter flashing. Added photos to minor repairs.

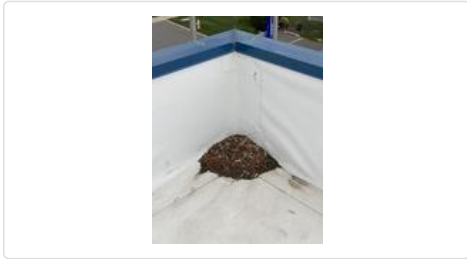
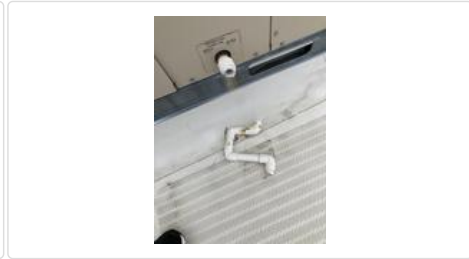
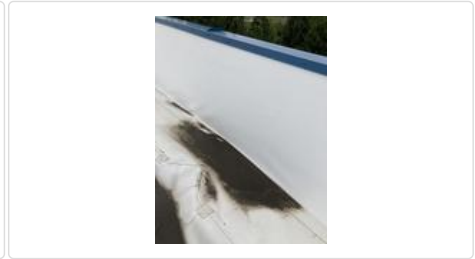
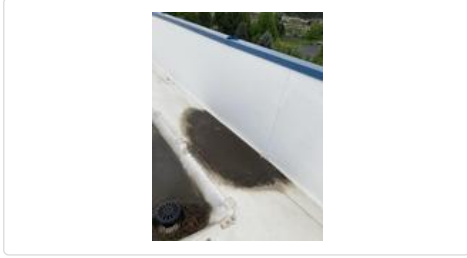
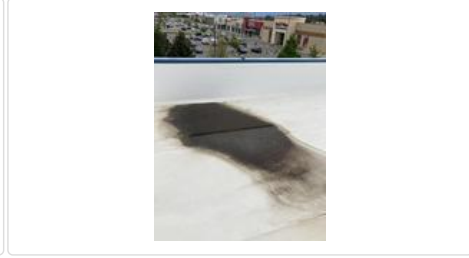
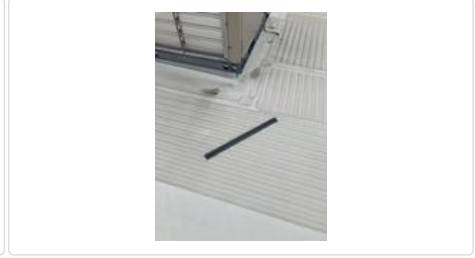
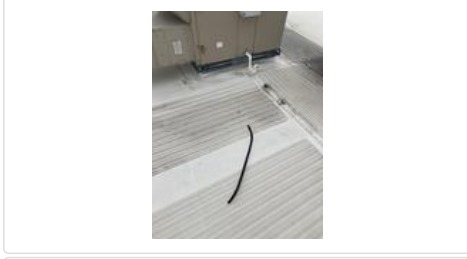
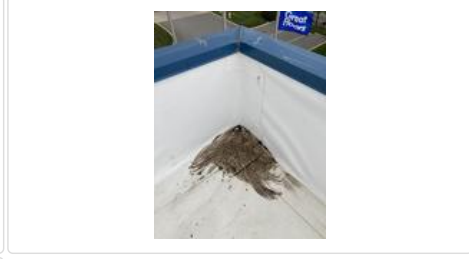
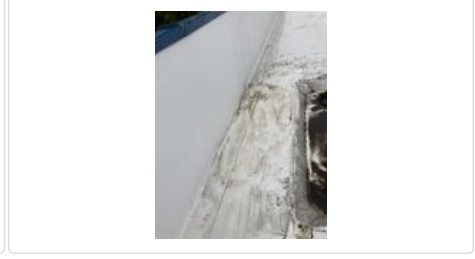
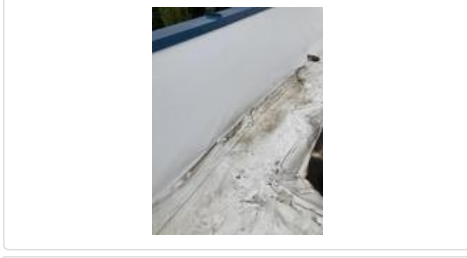
Remove Debris & Clean

There was a piece of metal next to one of the AC units. The overflow pvc pipe on one of the ac units broke off. A couple small piles of dirt, and leaves.
We cleaned up all the debris, and put everything in trash bags.
